CONSERVANCY CONSERVANCY BULLETIN

MAY 1920

MIAMI CONSERVANCY BULLETIN

The Flood of April 19-21

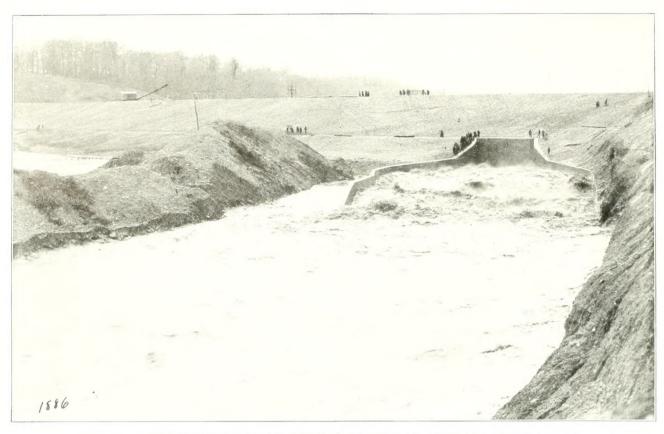
FIG. 123—HYDRAULIC JUMP AT GERMANTOWN DAM OUTLET, APRIL 20, 1920.

FIG. 124—HYDRAULIC JUMP AT GERMANTOWN DAM OUTLET, APRIL 20, 1920.

The dam crest is seen above the outlet, extending from hill to hill, blocking the valley. The flood water is coming through the outlet. In Fig. 123, the water at the highest point in the outlet channel was about six feet above its level at the conduit mouths. See also editorial, page 148.

In connection with the above, the reader should be warned that Figs. 123 and 124 do not show a true hydraulic jump action, as the conduit floors at Germantown are at present about 12 feet below their true level, in order to increase the conduit capacity while the dam embankment is under construction. This throws the action as described above, quite out of normal, through its adaptation to the temporary circumstances. At Lockington (Figs. 135 and 136) the conduit floors are at their final level (although the sides and arches are not completed), and the true action develops.

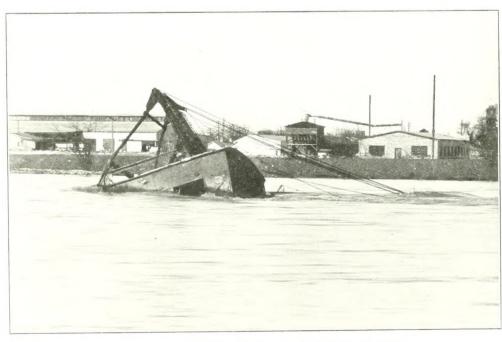
FIG. 127—DAYTON DRAGLINE, APRIL 20, 1920

This dragline excava-tor, a Class 175 Bucyrus machine, electrically driven, working weight about 200 tons, represents the greatest single item of injury wrought either to work or equip-ment by the flood. The unfortunate loss of two of the crew shortly before the flood, by drowning, was the probable ultimate cause of the accident to the machine itself, the remainder of the crew rightly giving first attention to the recovery of the lost bodies, with the result that the flood, when it came, found the machine in a position permitting it to be undermined.

The machinery was not materially damaged.

Conditions at Dayton have already been referred to. Probably the greatest single loss anywhere along the river was due to the undermining of the big Class 175 Bucyrus dragline excavator. The accident might not have occurred, probably would not, but for the unfortunate loss of the lives of two of the dragline crew a few days before, by drowning. The search for the bodies of these men naturally took precedence over regular work on the part of the rest of the crew, with the result that the flood found the machine in a position which permitted the undermining of one corner of the gravel island on

which it rested. (See also Figs. 127 and 128.)

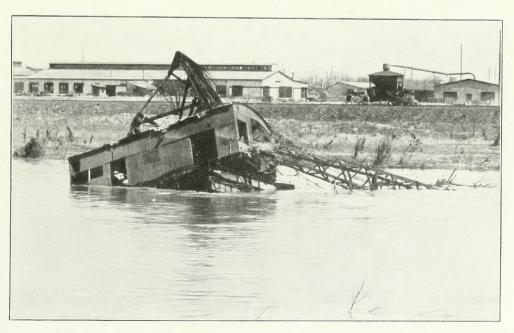
FIG. 128-THE DRAGLINE IN F G. 127, FOUR DAYS LATER.
